Moisture Content Monitoring of a Timber Footbridge

Niclas Björngrim, Olle Hagman, and Xiaodong (Alice) Wang*

The overall aim of this study was to evaluate tools and data for better planning of the inspections and to detect damage at an early stage for timber structure. The specific objective of this paper was to present the long-term MC monitoring of Älvsbacka Bridge and to evaluate the suitability of HygroTracs® as a MC monitoring system for timber constructions.

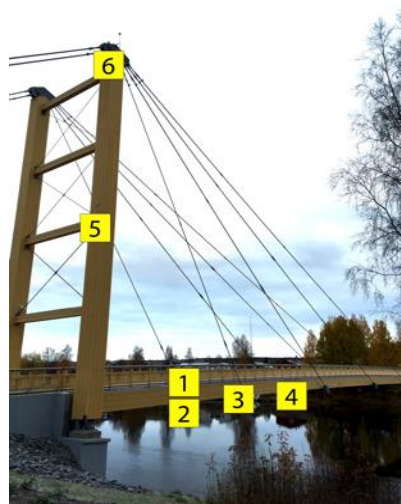
Fig. 2. Placement of HygroTrac® sensors on the bridge

Sensors 1 to 4 were placed beneath the bridge deck on the east-facing main glulam beam (Fig. 2). The first two (sensors 1 and 2) were mounted 7.2 m from the south abutment at both the top and bottom of the primary beam. Sensor 1 was mounted at the top of the beam just beneath a ledge and was used to compare with sensor 2, which is mounted beneath at the bottom of the beam (Fig. 3). Just above sensor 2 was a metal fastener for the transverse beams where water would pour down along the edge of the metal fittings; high levels of MC were expected to be found there. Sensor 3 was mounted 12.2 m from the south abutment, and sensor 4 was located 26.5 m from the south abutment.

Sensors 5 and 6 were mounted on the southeast pylon (Fig. 2). Sensor 5 was placed at the middle, 11.5 m from the bridge deck, and sensor 6 was at the top, 23 m from the bridge deck. The sensors on the pylon were shielded by the cladding protecting the glulam.

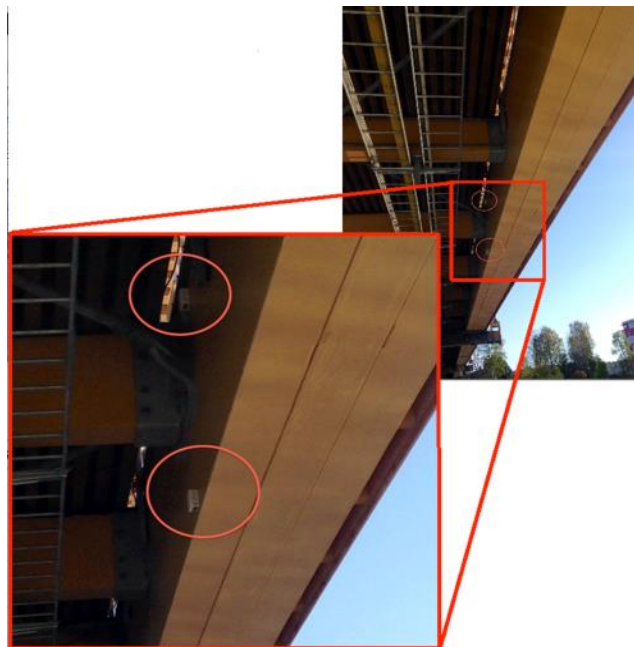
Fig. 3. Photographs showing sensor 1 at the top and sensor 2 at the bottom of the glulam beam

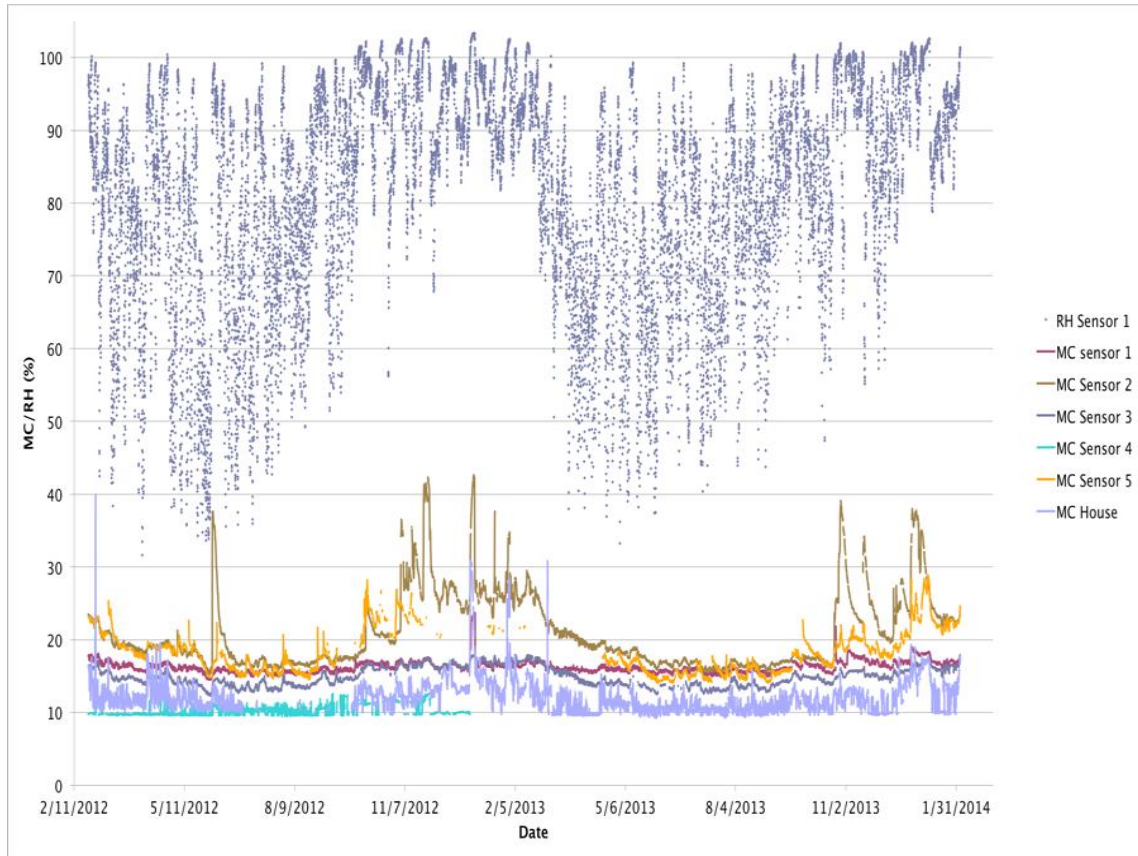
Fig. 4. RH vs. MC for all sensors

The measured RH vs. MC and temperature vs. MC for all sensors are displayed in Fig. 4 and 5, respectively. All six sensors showed similar readings for RH and temperature. Therefore, only one curve from sensor 1 was chosen to represent the RH or temperature in the figure. Of the six sensors, two malfunctioned. Sensor 6, located at the top of the pylon, only sent data for a few days, which is not presented here. Sensor 4 stopped working after 10 months. This could be battery-related or due to condensation, snow, or faulty hardware. Sandberg *et al.* (2011b) reported similar experiences. The RH varied between 35% and 100% over the year (Fig. 4); the RH was higher during winters and lower during summers. It was the same trend for the MC readings, which showed the highest values during the winters and the lowest during the summers. The temperature vs. MC is demonstrated in Fig. 5, and ranged from -20 to 25 °C. The temperature was higher in summers and lower in winters, just opposite to MC readings.

Sensor 1 (red line in Fig. 4 and 5), located at the top of the main beam, at a location protected from water flowing down through the bridge deck, showed expected behavior, with a MC under 20% except for a few peaks. Sensor 2 (brown line in Fig. 4 and 5), placed at the lower end of the glulam beam, was more exposed to water pouring through from the open bridge deck. Thus, it showed the highest MC, reaching well over 40% for short periods and over 25% for long periods during the winter. MC over 40% is not within the calibrated interval of the sensor and is probably due to water pouring/melting down and pouring into the borehole. It is reasonable to expect that if the borehole for the sensor had not been mounted, the free water would not be able to penetrate the painted surface of the beam and the MC would be approximately 15% to 20% (below the FSP), similar to the close-by and protected sensors. From Fig. 3, it can be seen that there were no visible cracks nearby the sensor 2. Therefore, even though the MC was varying over and under the FSP, it does not seem to have affected the timber, which is a good indication that it was just water in the borehole that was responsible for the elevated MC values.

Sensor 3 (dark blue line in Fig. 4 and 5) showed behavior similar to that of sensor 1, with a MC below 20%. Sensor 4 (light blue line in Fig. 4 and 5) reported the lowest MC levels until the failure. Sensor 5 (yellow line in Fig. 4 and 5), located inside of the protective cladding on the pylon, showed higher MC than the sensors in the main beam, reaching over 30%. It reported a MC above 20% in September to October 2012 and January 2014, which must be further investigated. Sensor 5 suffered from some sort of malfunction and had problems sending data, with limited data acquisition between December 2012 and April 2013. Viitanen (1994) states that the critical humidity level for fungi growth was RH at

80% and over, with temperatures above 20 °C. Although RH values were high during December to February, the low temperature was not favorable for fungal growth.

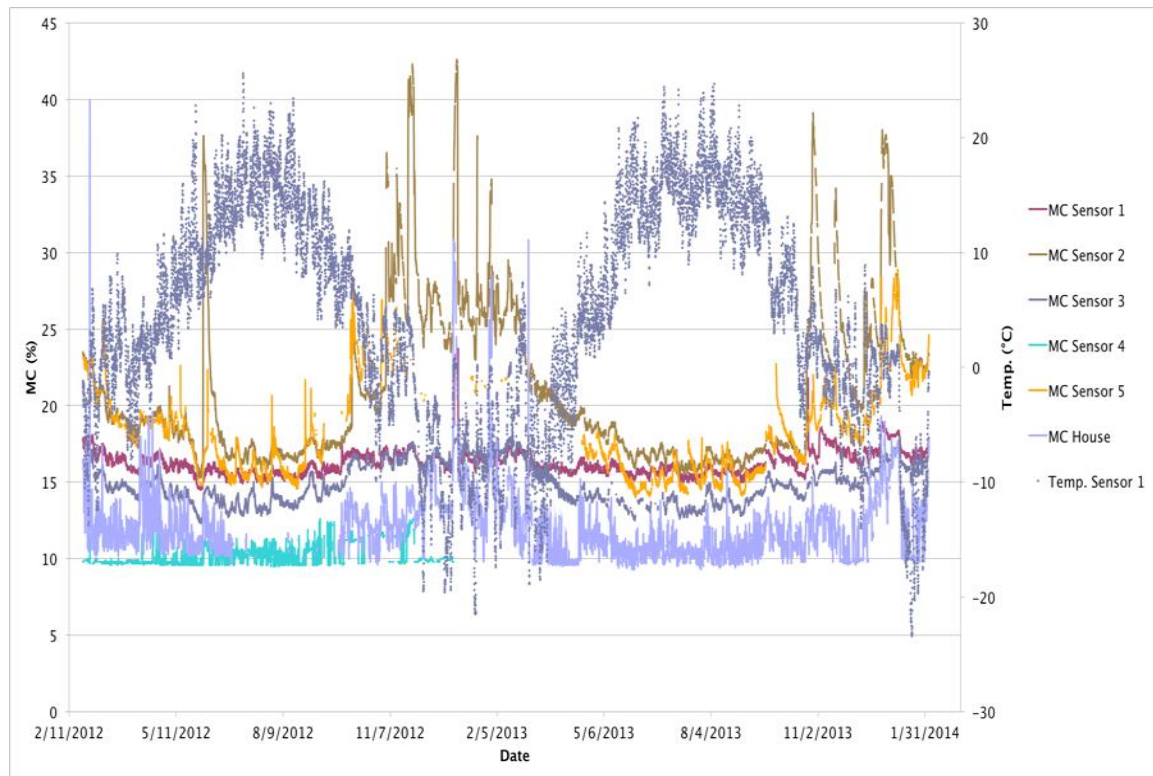
Fig. 5. Temperature vs. MC for all sensors

One of the sensors from the nearby timber building was used for comparison with the bridge data. Purple lines in Fig. 4 and 5 show the measurements of this sensor. Although the RH values were generally lower, the trend was similar to the RH measured at the bridge. The higher RH values for the sensors on the bridge could be due to the moisture from the nearby river. The MC of the sensor on the timber building was quite steady at approximately 10% to 15%, with a few peaks over 20%. The same problem as with sensor 5 was also present here: for a period of a few months, only very sporadic measurements were reported.
