Poe Hall - Summary

March 22, 2022

The purpose of this discussion is to provide an update on the planned project and discuss path forward for HVAC system

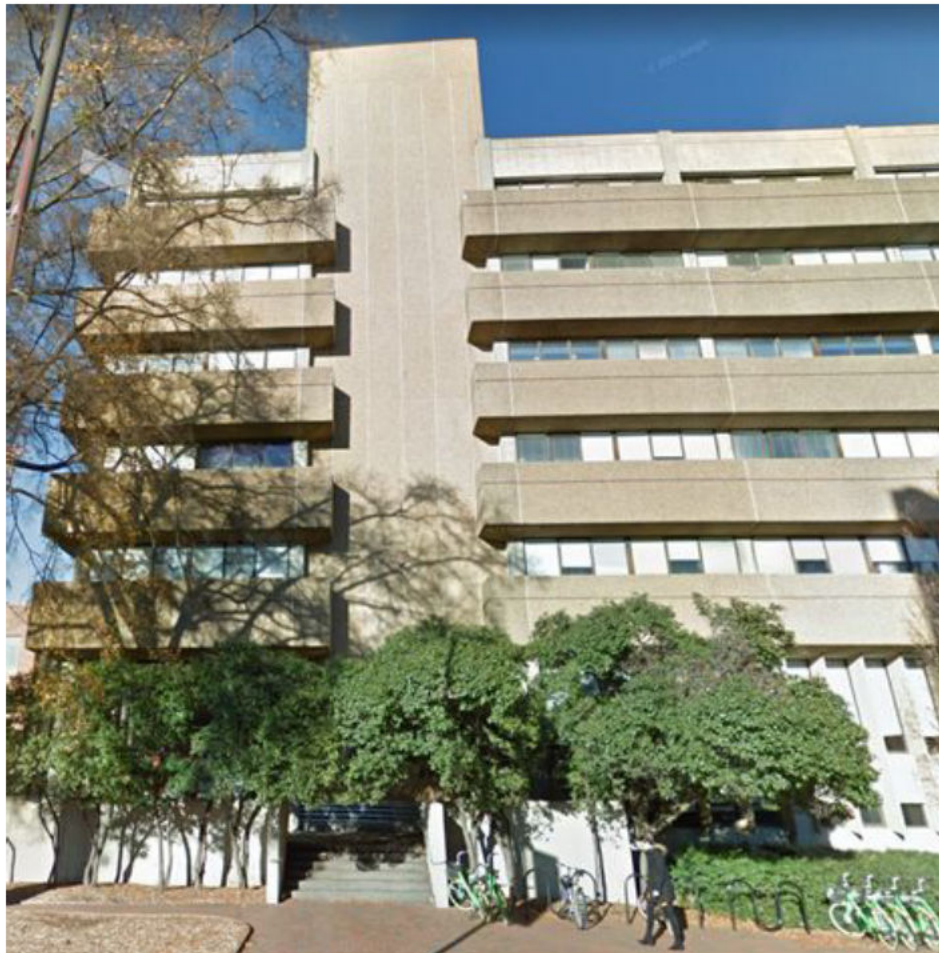
- Ductwork in vertical shaft and external horizontal shaft
- Interior lined ductwork is failing
