WOOD MACHINING & TOOLING RESEARCH

WMTRP TECHNICAL NOTE: CNC ROUTER BALANCE PROBLEMS

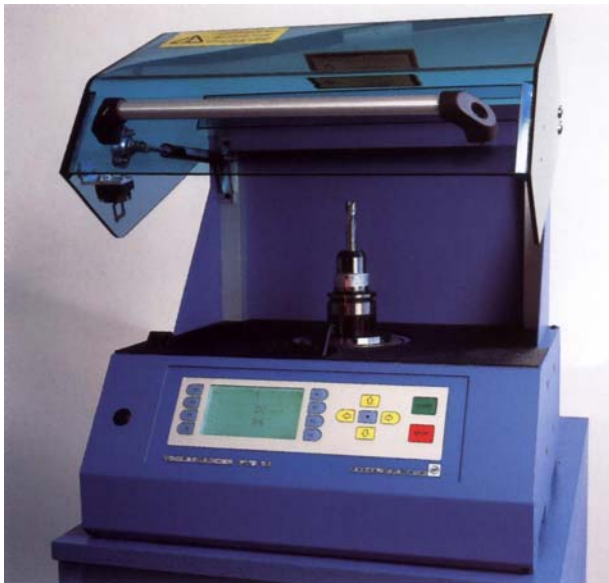
Balancing Machine for Tools and Chucks

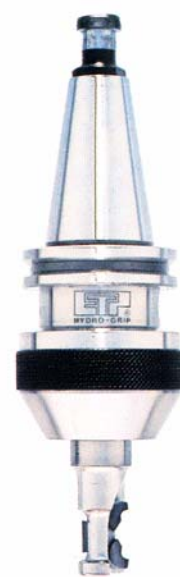
Hydraulic Chuck for Router
